## WEEKLY STATUS REPORT

BCP Project No.:	C224099	EPA Consent Order No.:	CERCLA-02-2017-2021	Date:	07/29/2019
Project Name:	BRT Powerhouse 153 2 <sup>nd</sup> Street AKA 322 3 <sup>rd</sup> Avenue, Brooklyn, NY 11215				
Remediation Activities (Week of July 22, 2019): <ul style="list-style-type: none"><li>Continued gauging and product recovery via absorbent sock as necessary.</li></ul>					
Redevelopment Activities (Week of July 22, 2019): <ul style="list-style-type: none"><li>Maspeth Welding (Site steel contractor) continued steel repair work in the turbine hall.</li><li>Continued general site maintenance.</li><li>Continued site surveying work as necessary.</li><li>Structure Tech (Site contractor) continued installing support of excavation (SOE) pilings in the north Site driveway. Thirteen (13) pilings were installed this week to approximately 22-25 ft bls. Structure Tech continued grouting the completed pilings in the north Site driveway.</li><li>Structure Tech continued trenching in the north Site driveway for SOE installation for future redevelopment utilities.</li><li>Darcon (Site soil contractor) completed unloading the 100-150% interval of the turbine hall load test and bega

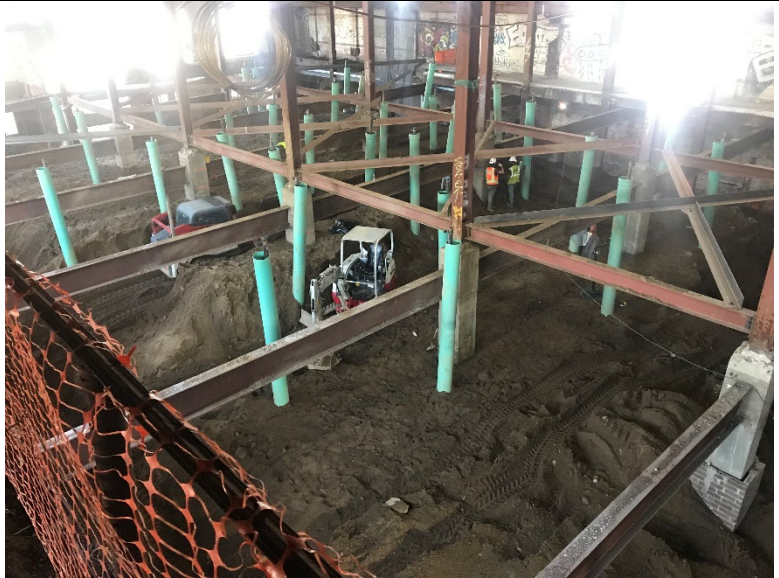
Photo 1 – Looking west inside the turbine hall. Darcon unloads the 50-100% interval of the turbine hall load test.

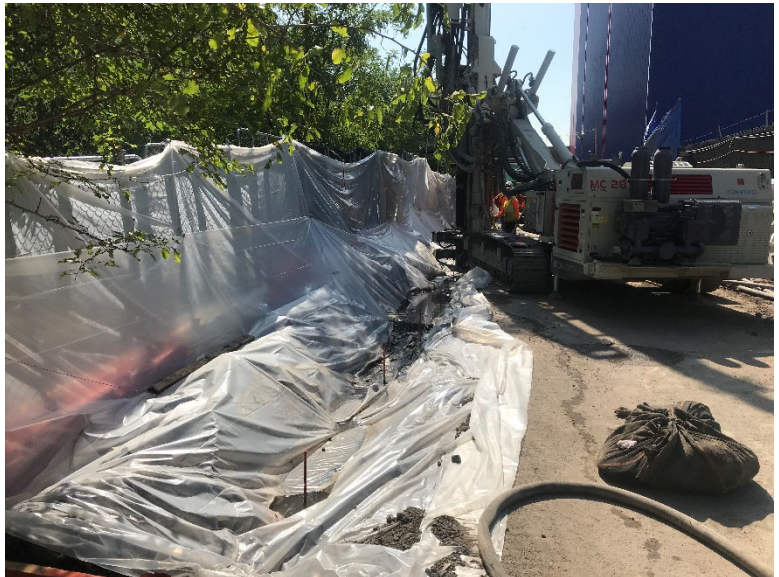
Photo 2 – Looking east in the north Site driveway. Structure Tech continues installing SOE pilings. Utilizes trench for drill water redirecting and recirculating.

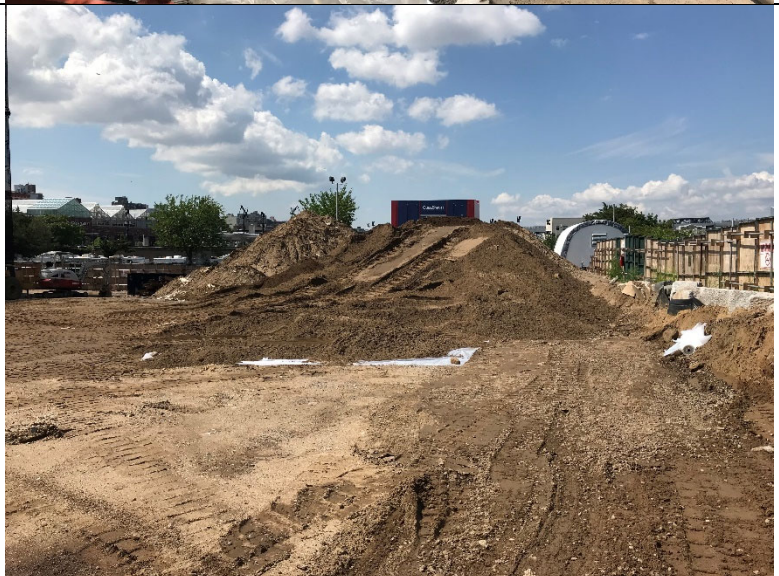
Photo 3 – Looking south from the west side of the Site. Current state of the turbine hall load test soil stockpile.
